HARFORD COUNTY DPW

UPPER FARNANDIS SMALL WATERSHED ASSESSMENT REPORT

APRIL 02, 2018

HARFORD COUNTY DEPARTMENT OF
PUBLIC WORKS

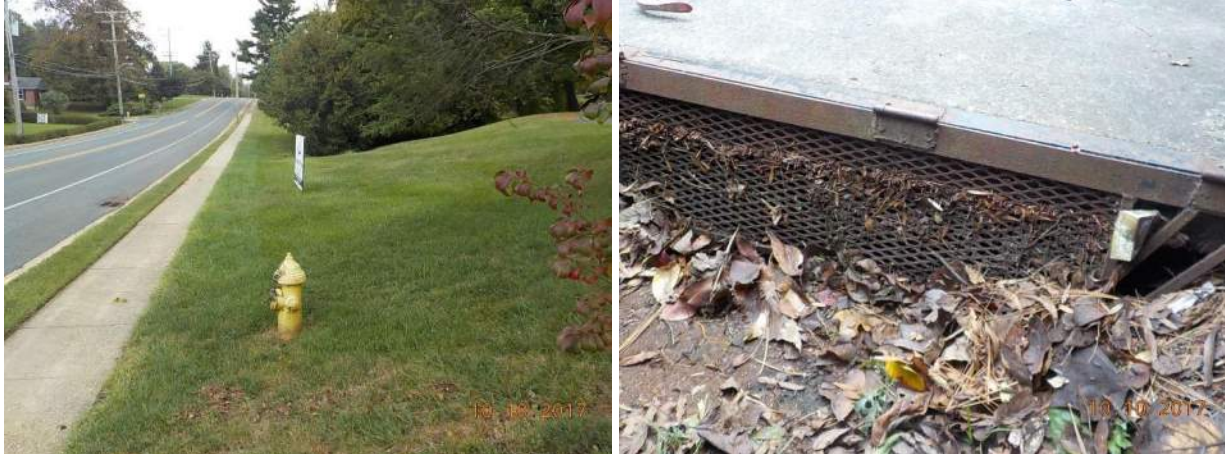
Rain had been observed in the area one day prior to site visit. No flow was observed near or in to the underground facility. The underground dry well infiltration facility is not being recommended as a retrofit opportunity. It appears to be functioning as designed and is currently providing water quality benefits; however, maintenance is recommended in the form of removal of accumulated sediment.

Figure 4-2: Looking Southwest adjacent to E Macphail Road at ground above underground facility (left); Looking at clogged inflow point located in parking lot (right)

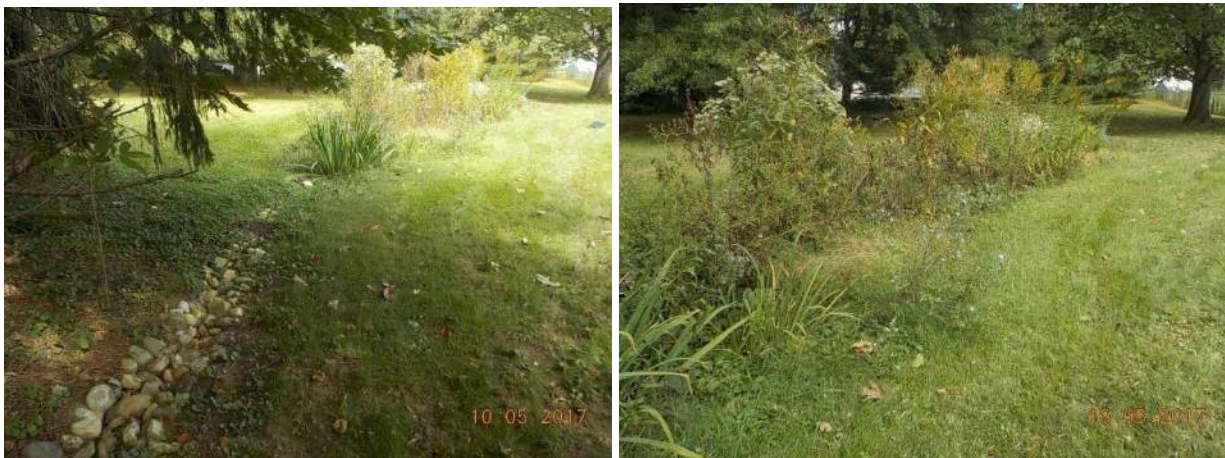
No flow was observed to the facility. Rain had not been observed in the area 3 days prior to site visit. There was no standing water in the facility. The existing rain garden is not being recommended as a retrofit opportunity. It appears to be functioning as designed and providing water quality treatment.

Figure 4-3: Looking North along existing riprap channel leading to rain garden (left); Looking North at existing facility (right)

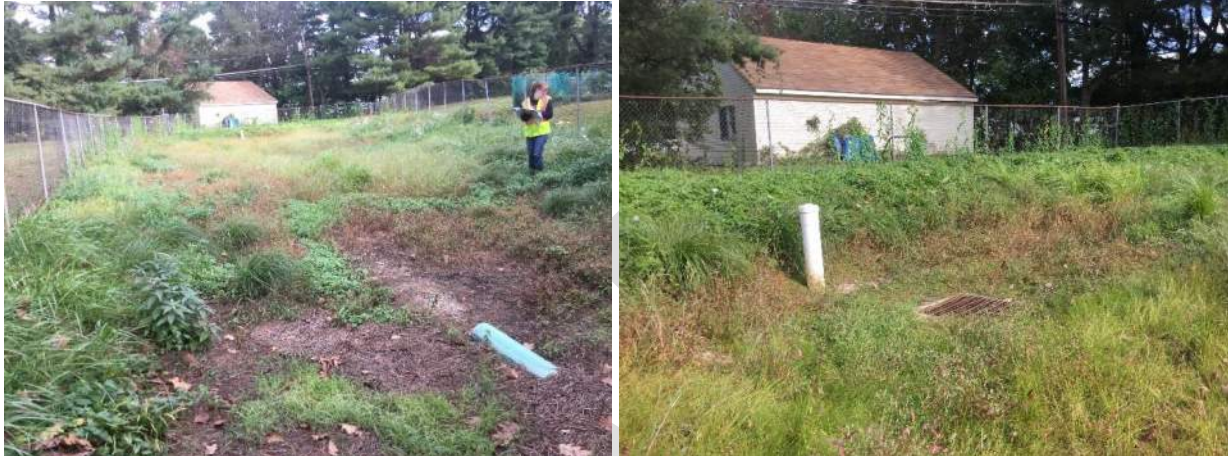
No flow was observed to the facility. Rain had not been observed in the area within 3 days prior to the site visit, and the facility did not have standing water present. The existing infiltration trench is not being recommended as a retrofit opportunity. It appears to be functioning as designed and providing water quality treatment; however, maintenance is recommended in the form of sediment removal in the detention basin.

Figure 4-4: Looking North to facility footprint from inflow point (left); Looking North to outfall to existing storm drain network (right)

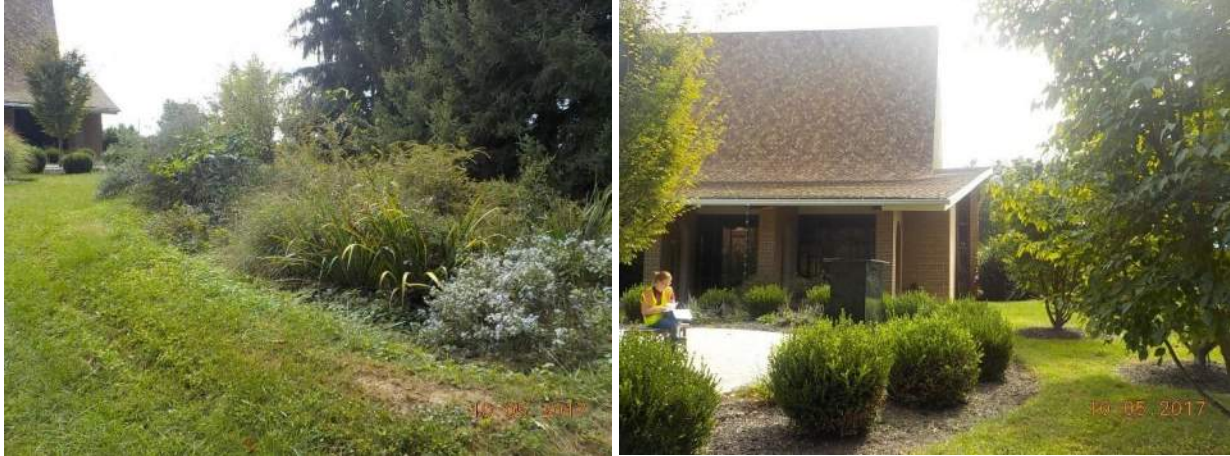
No flow was observed to the facility. Rain had not been observed in the area 3 days prior to site visit. There was no standing water in the facility. The existing rain garden is not being recommended as a retrofit opportunity. It appears to be functioning as a water quality treatment facility.

Figure 4-5: Looking South to existing rain garden facility (left); Looking South to area of church roof that drains to existing BMP (right)

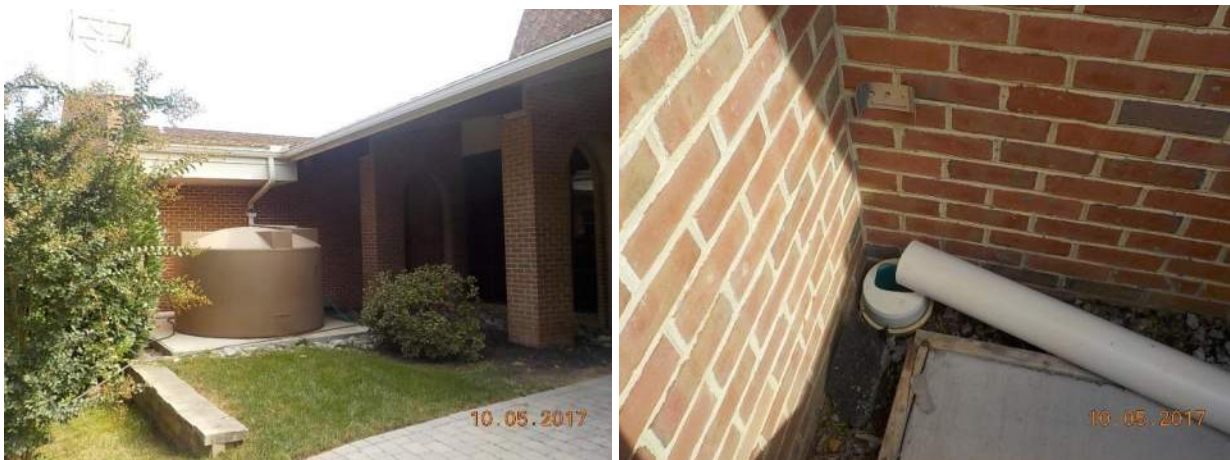
During the field visit, no flow was not observed to the facility. Rain had not been observed in the area within 3 days prior to site visit. The existing rain barrel is not being recommended as a retrofit opportunity.

Figure 4-6: Existing rain barrel captures runoff from roof (left); Overflow to existing pipe network that outfalls to grass area to North of rain barrel (right)

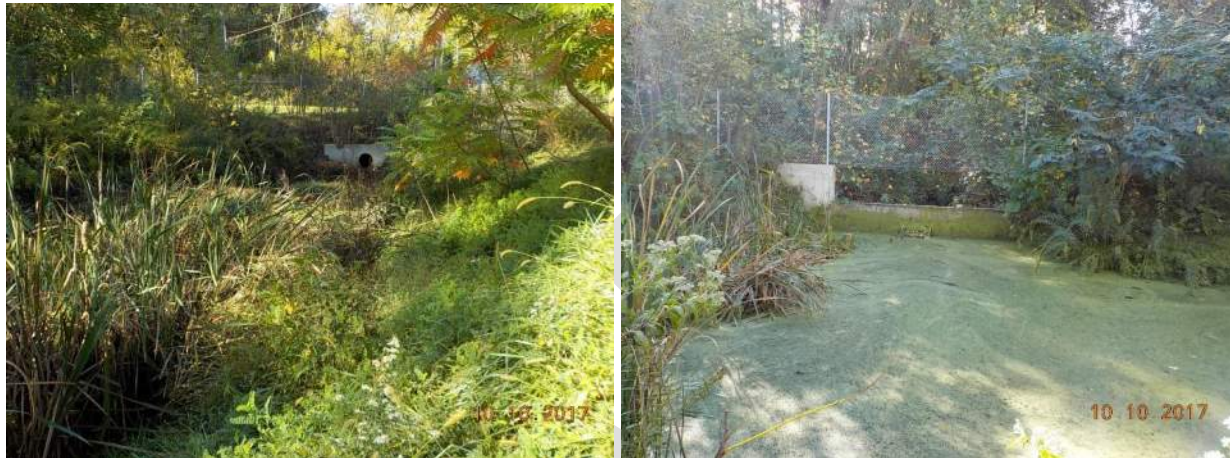
Inflow was observed to the facility. Rain was observed in the area one day prior to the site visit. As expected, standing water was present in the wet pond footprint. The existing wet pond is not being recommended as a retrofit opportunity.

Figure 4-7: Looking West to South Main Street at location of inflow pipe (left); Looking South at overflow weir (right)

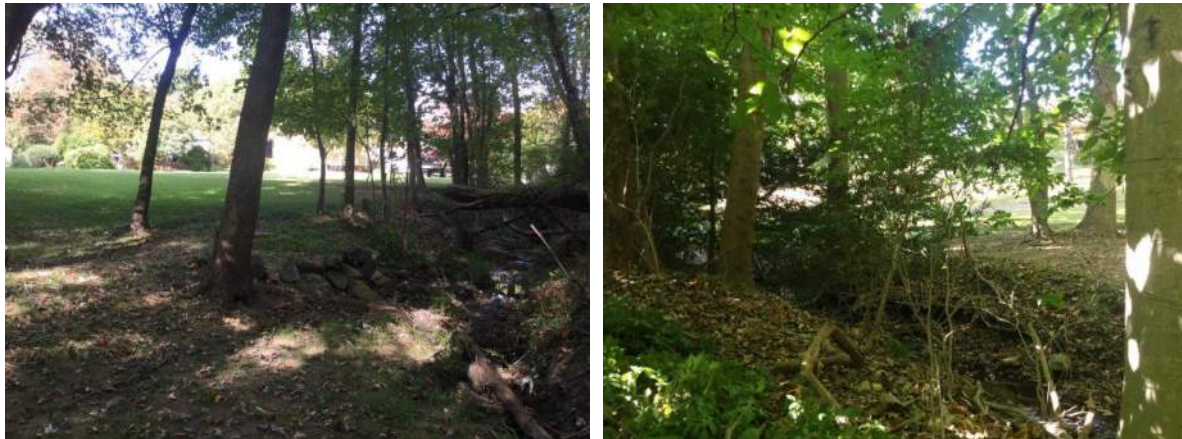
Figure 4-11: Examples of Severe (left) and Moderate (right) Inadequate Stream Buffer Locations in Upper Farnandis Watershed

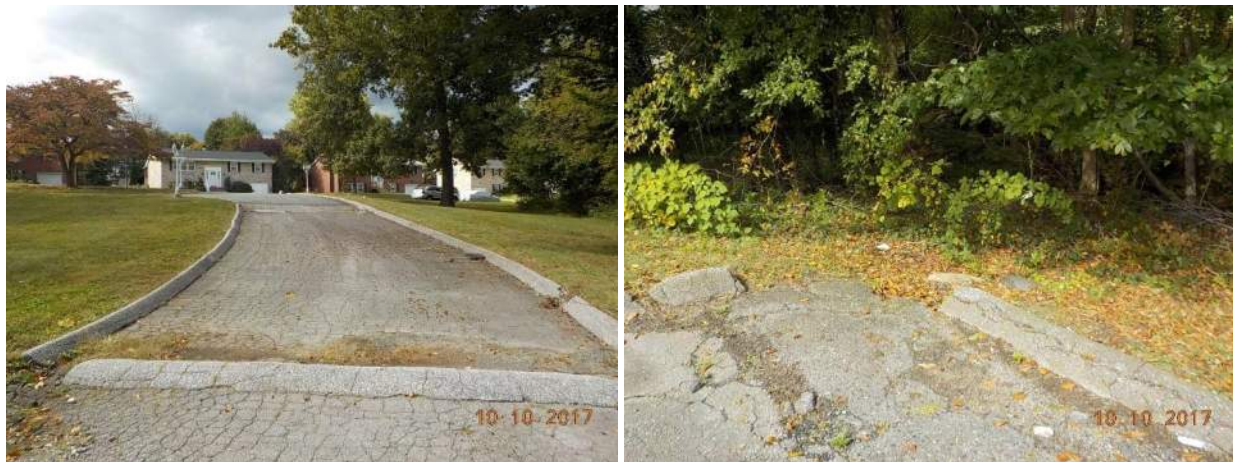
Figure 6-11: Looking West along driveway entrance to Mariner Health (left); Looking East to existing deteriorated curb within parking lot at Mariner Health (right)

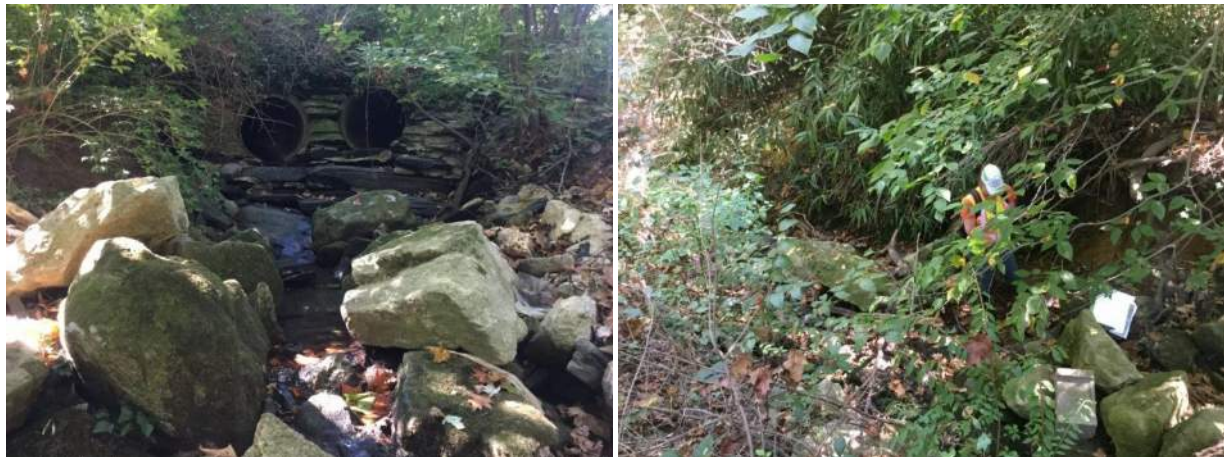
Figure 6-15: Looking upstream towards Outfall 24 (left); Looking downstream of Outfall 24 (right)

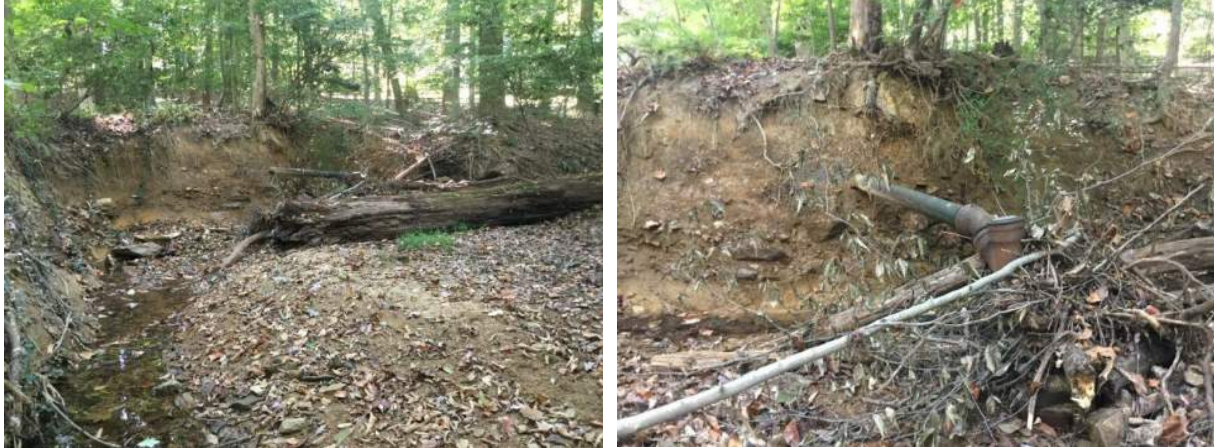
Figure 6-16: Looking upstream at 9 feet eroded right bank (left); Looking towards right bank at exposed pipe (right)

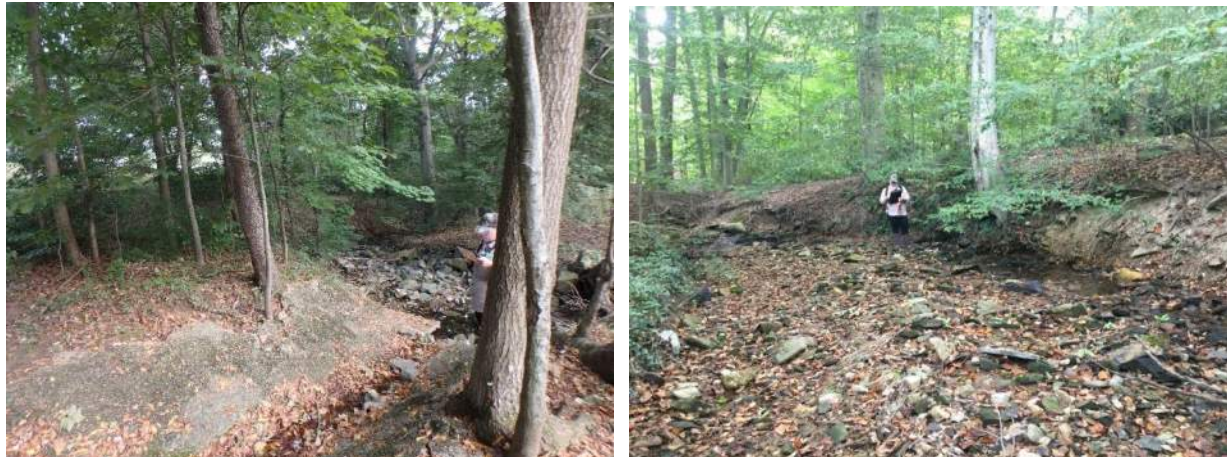
Figure 6-18: Looking downstream at erosion at end of channel alteration at 114 East Ring Factory Rd (left); Erosion downstream of channel alteration (right)

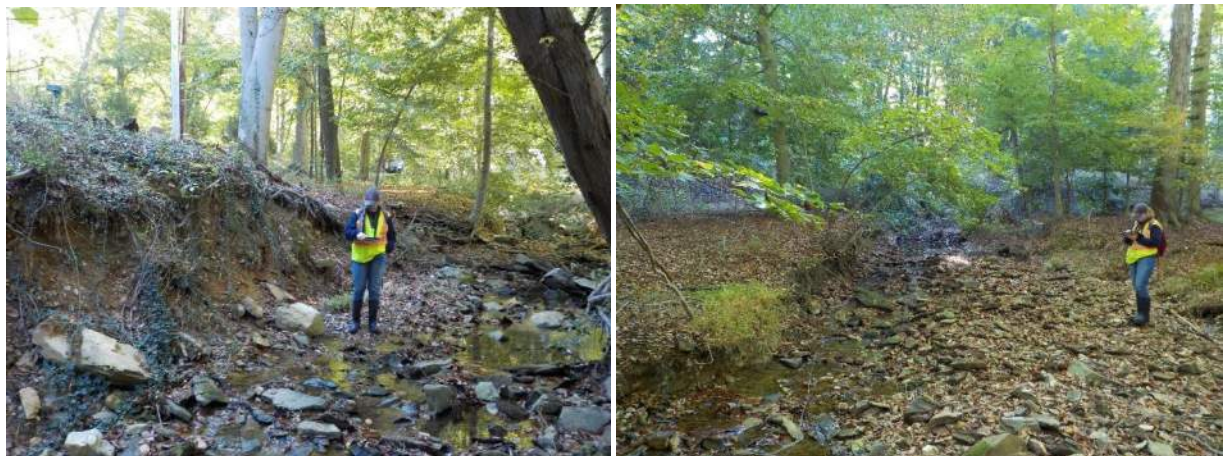
Figure 6-19: Looking upstream at 4 Carolina Ave, Steep banks creeping towards Carolina Ave (left); Bank heights are lower further downstream on property 4 Carolina Ave (right)

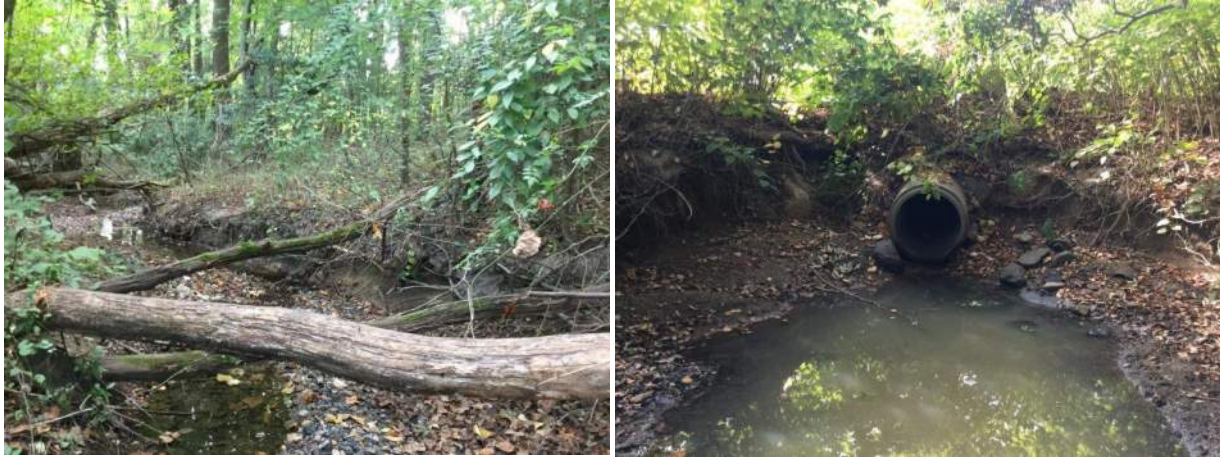
Figure 6-22: Erosion downstream of Outfall 38 (left); Scour hole and erosion on left and right banks of Outfall 39 (right)

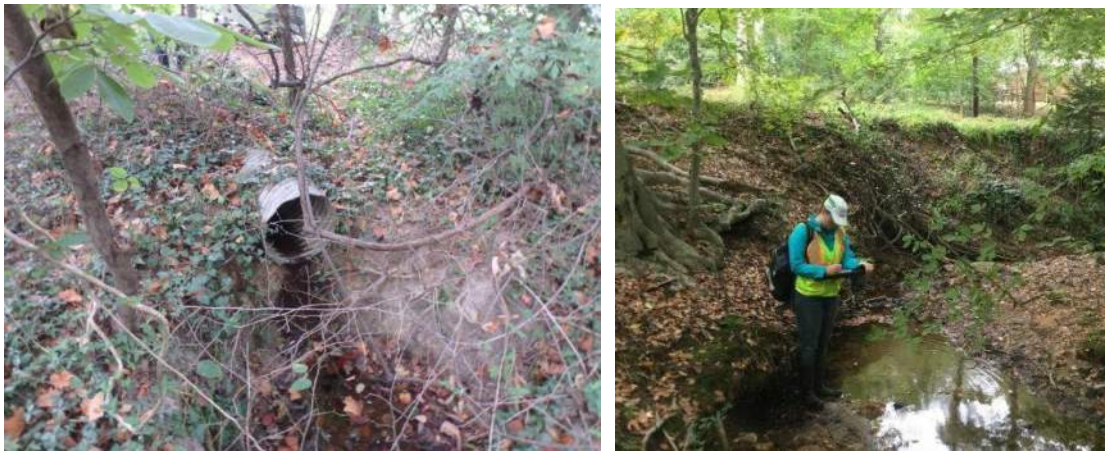
Figure 6-23: Looking towards the left bank at Outfall 23, (left); Erosion on left bank reaches the edge of Victory Lane at the top of the bank, 9 feet bank (right)

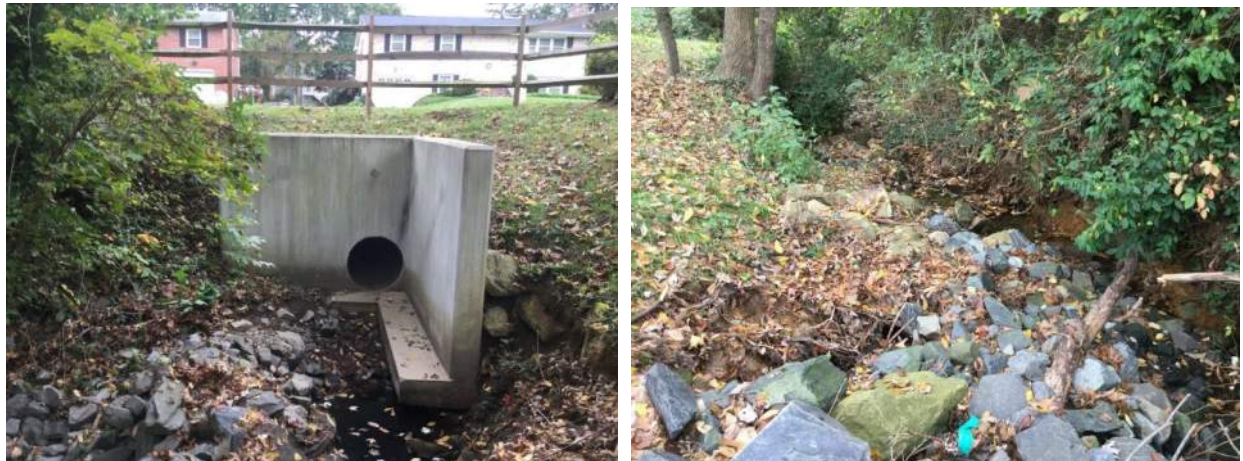
Figure 6-27: Looking upstream at Outfall 01, erosion on left bank and scour hole at end of outfall structure (left); Looking downstream from Outfall 01, erosion on right bank (right)

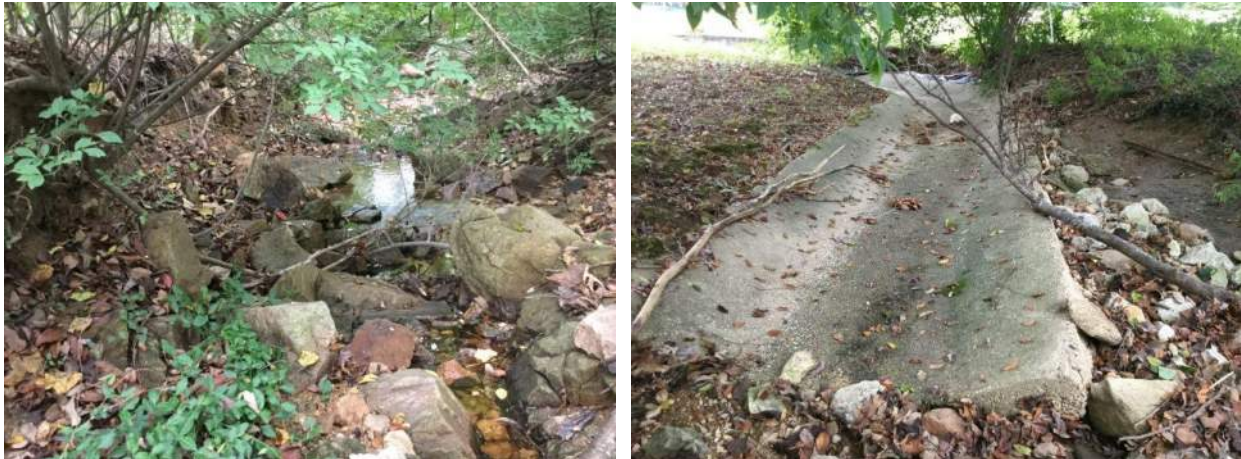
Figure 6-28: Looking downstream at start of erosion on left bank (left); Looking downstream at concrete channel, flow diverted to the right of the concrete channel prior to East Macphail Road (right)

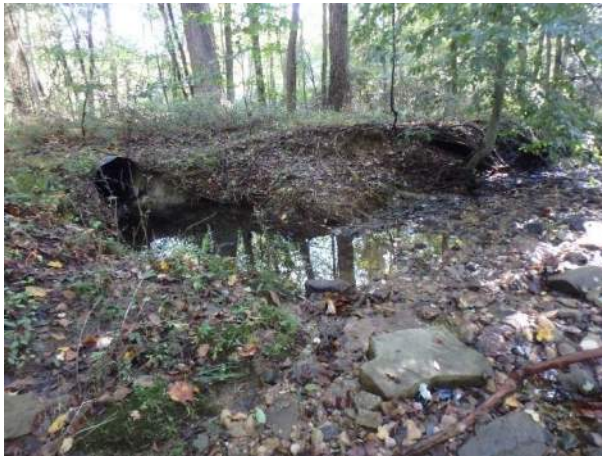
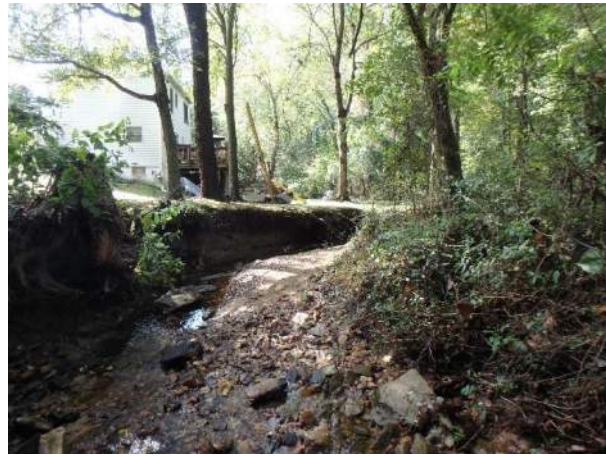
Figure 6-32: Looking towards the left bank at Outfall 05, scour hole (left); Inadequate buffer and erosion on left bank of G-T1, downstream of Outfall 06 (right)

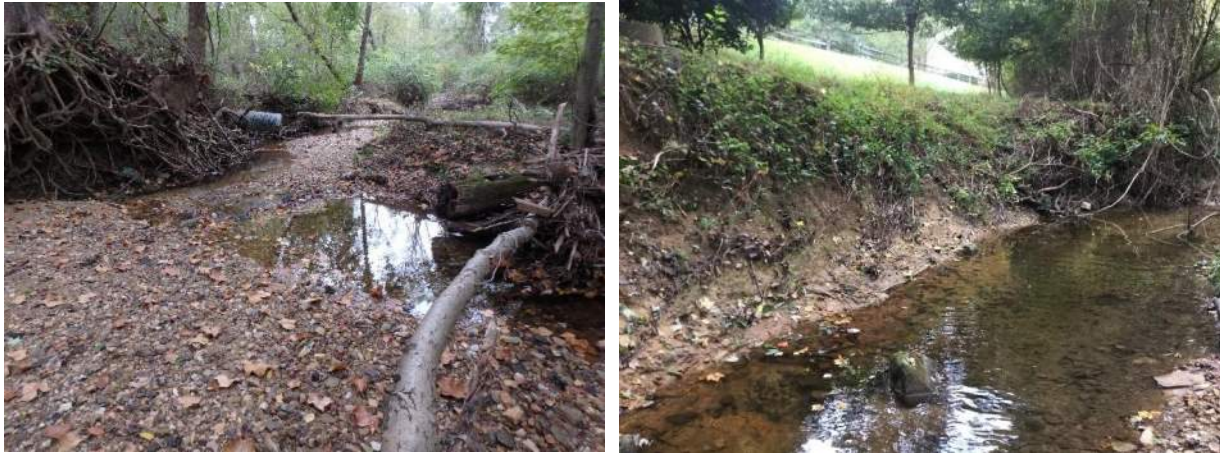
Figure 6-33: Looking downstream towards the left bank at Outfall 08 (left); Looking upstream, inadequate buffer and erosion on right bank of main stem, at watershed outlet (right)

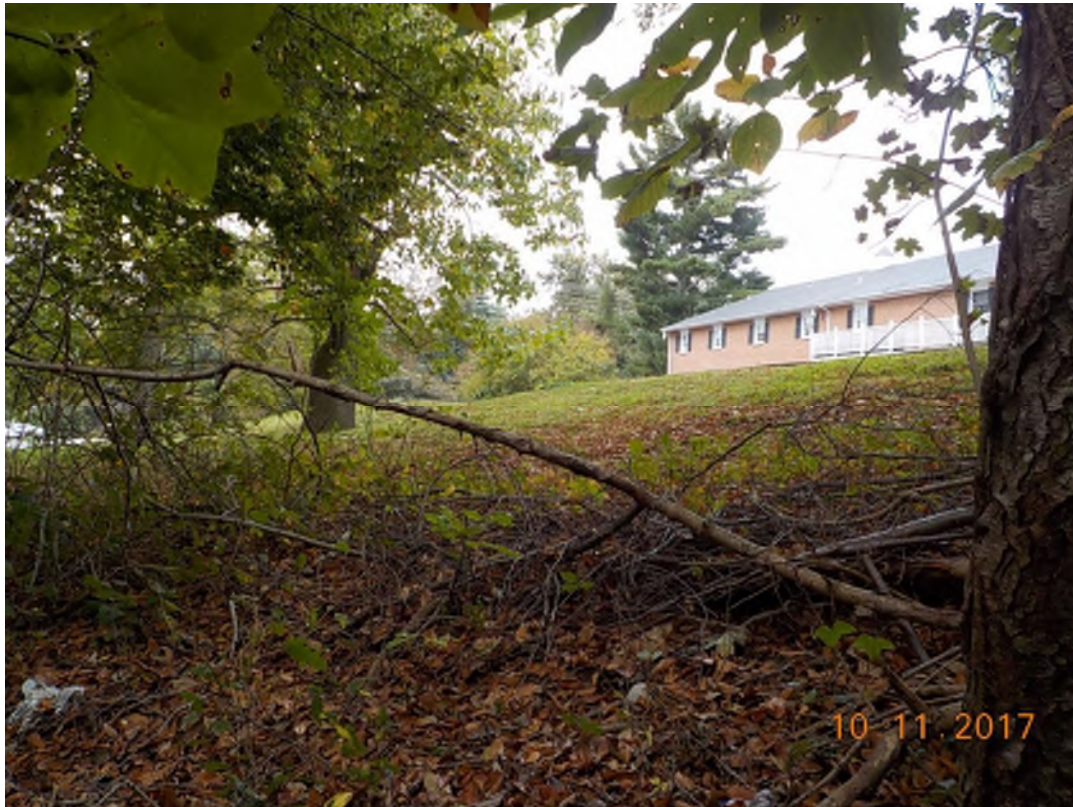
Figure 3: Inadequate buffer in tributary 2 of Macphail subwatershed.

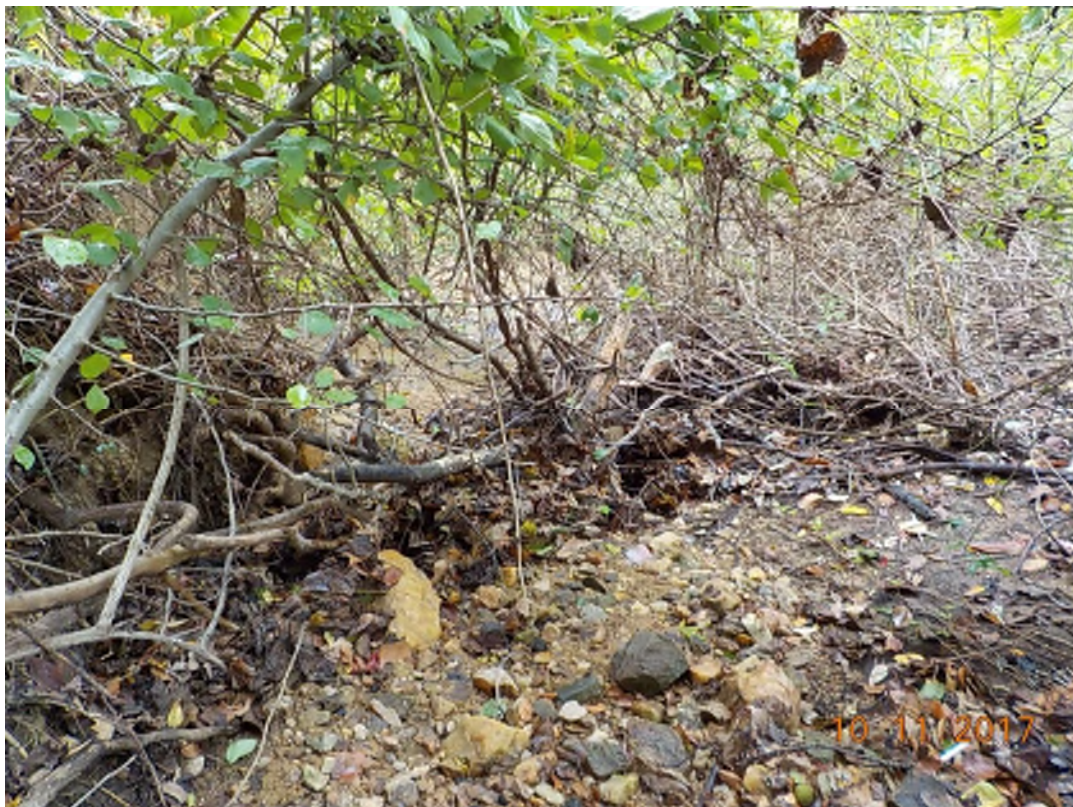
Figure 4: Debris jam in tributary 2 of Macphail subwatershed

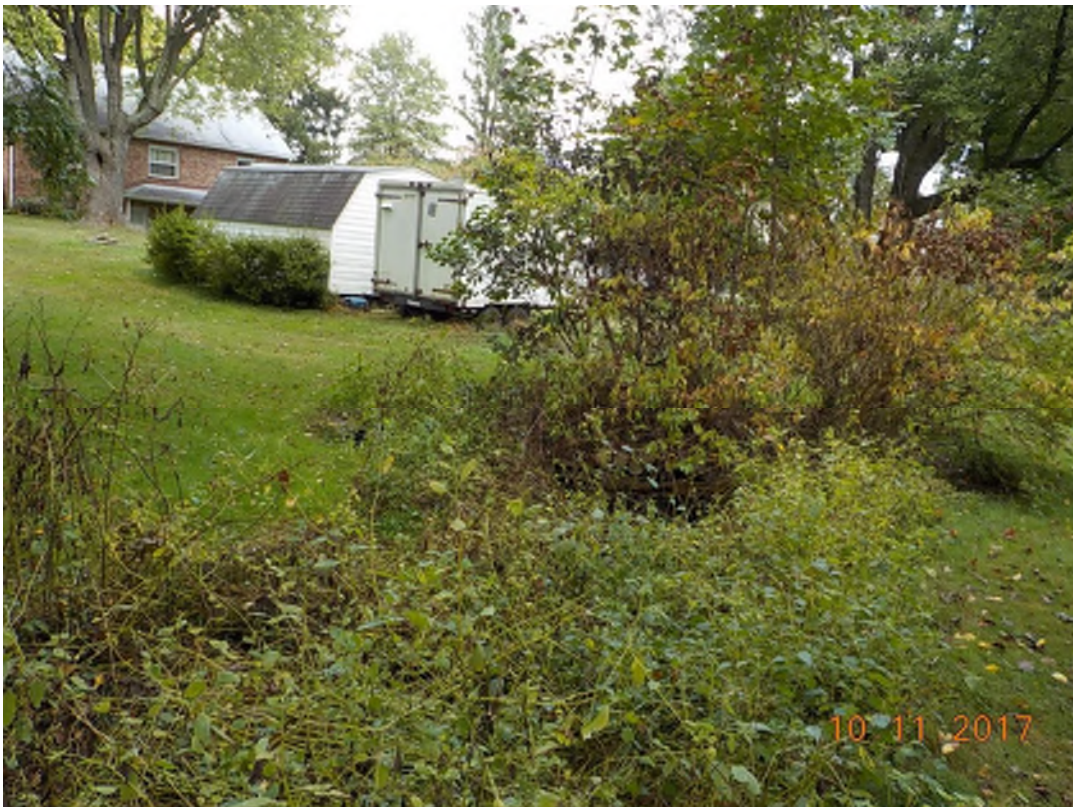
Figure 8: Inadequate stream buffer adjacent to each side of tributary 1, in residential backyards.

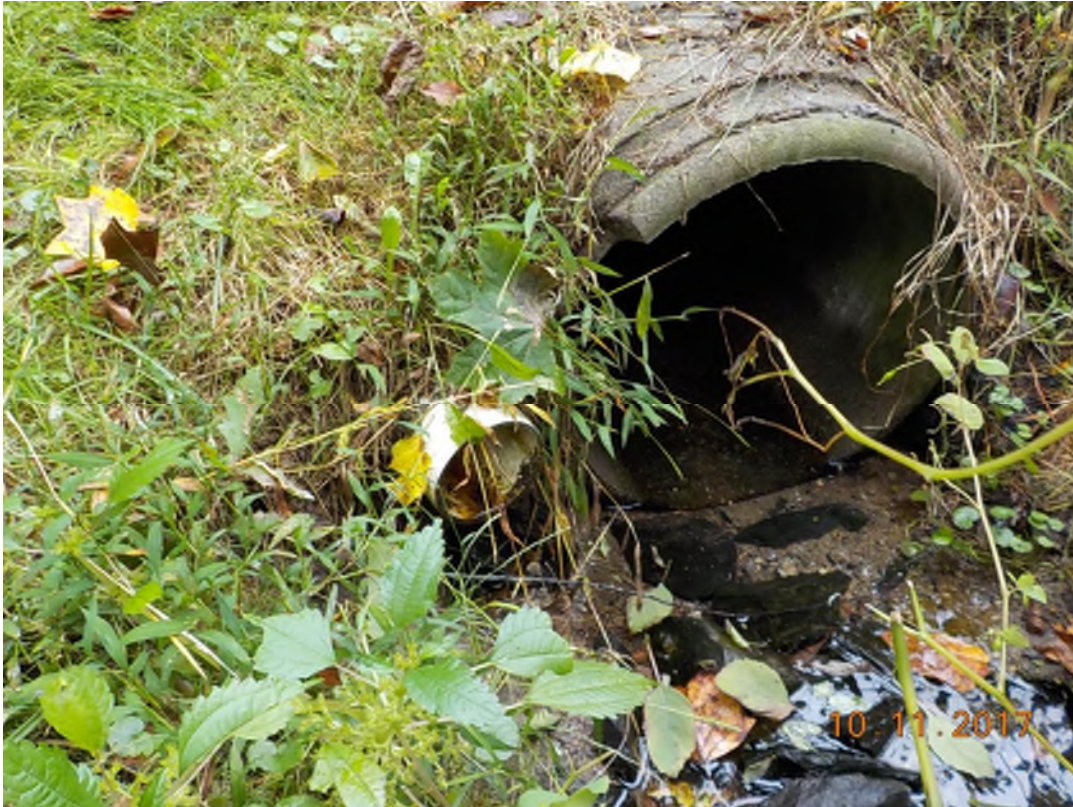
Figure 9: Outfall 20 enters left bank of tributary 1. Outfall is 18" concrete pipe approximately 7 feet from stream.

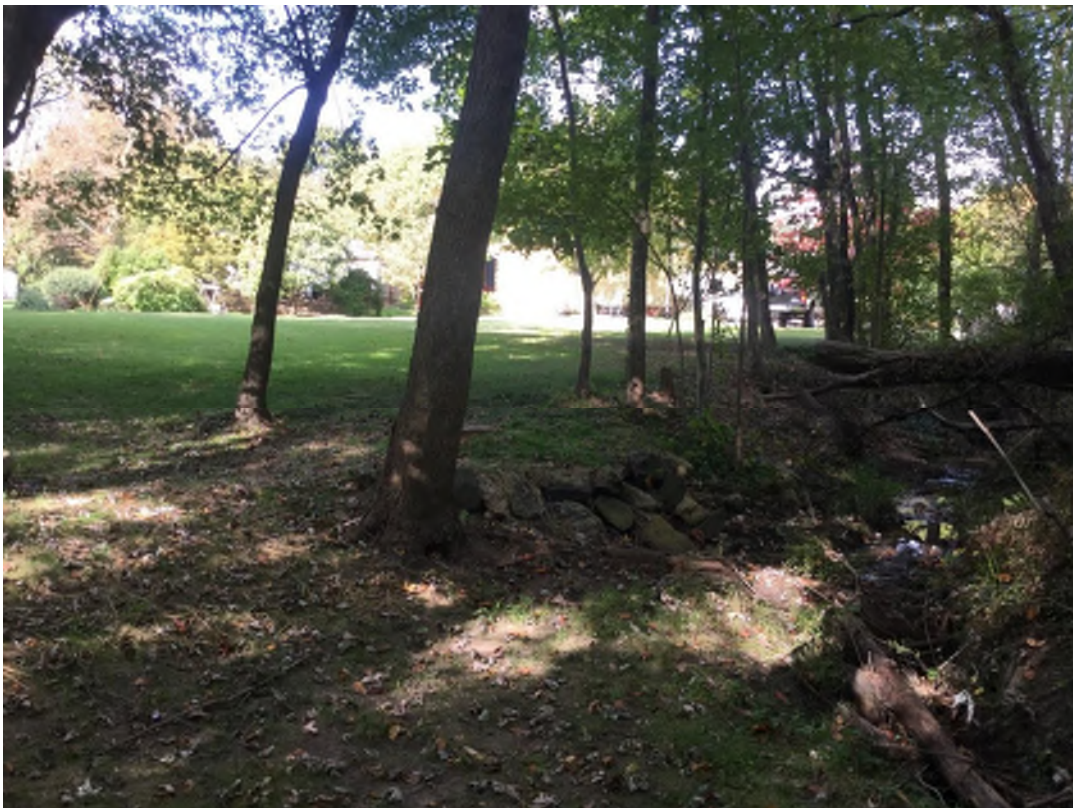
Figure 4: Inadequate buffer in tributary 1 of subwatershed prior to outfall 18.

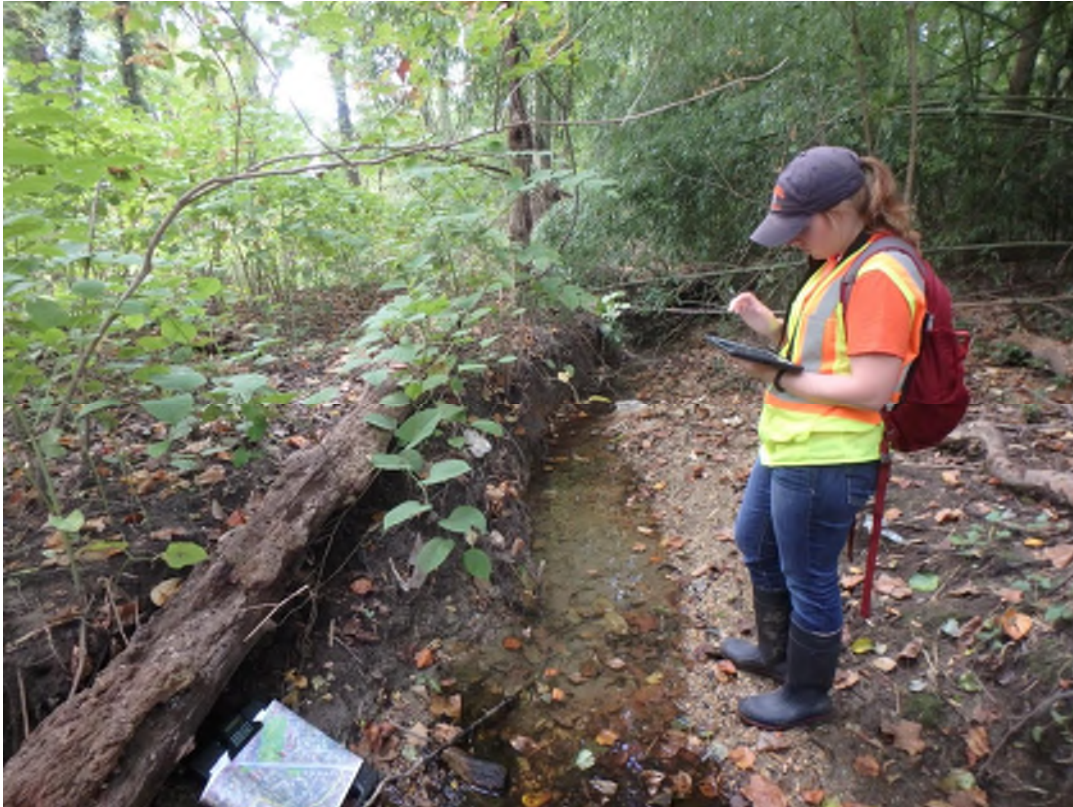
Figure 5: Bank erosion along tributary 1 in subwatershed prior to outfall 23.

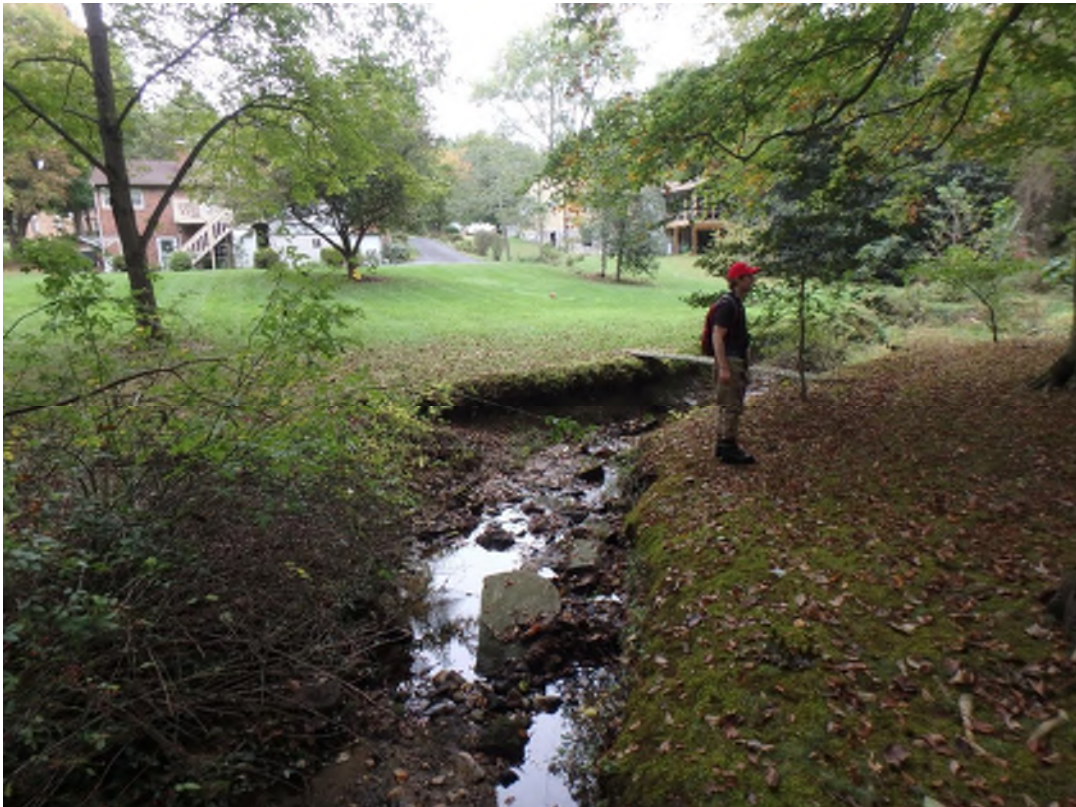
Figure 10: Bank erosion and inadequate buffer downstream of outfall 23 in tributary 1.

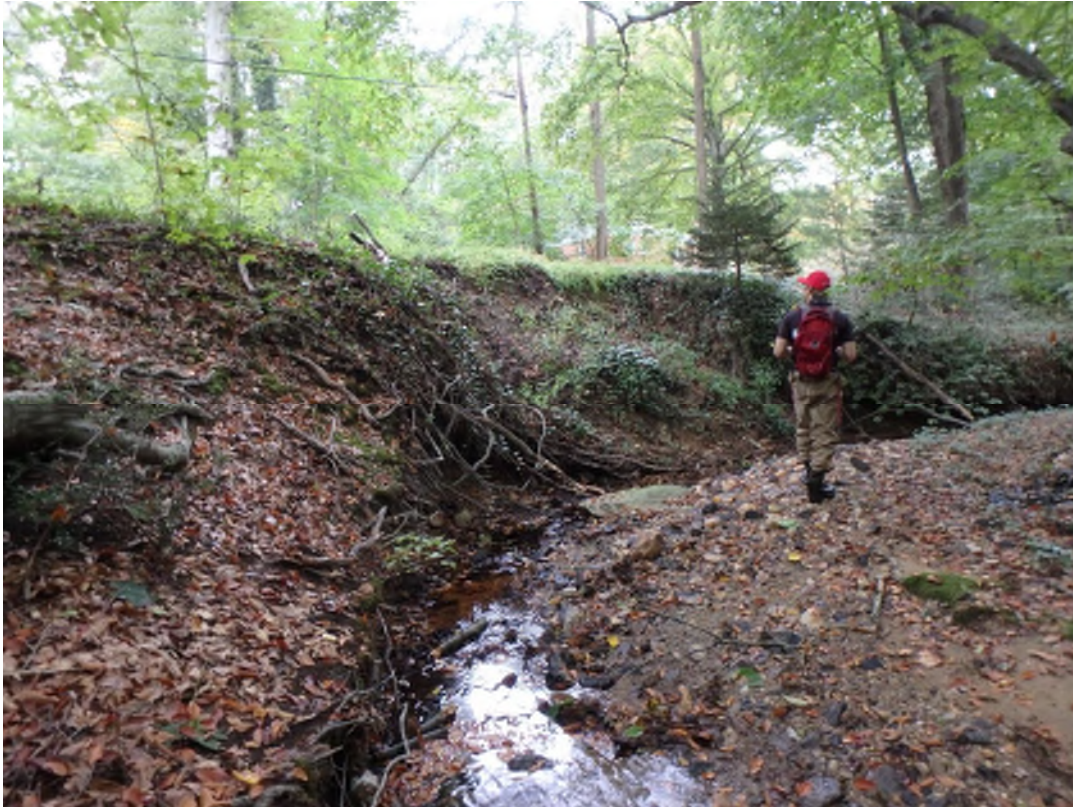
Figure 11: High banks resulting from erosion in tributary 1 channel.

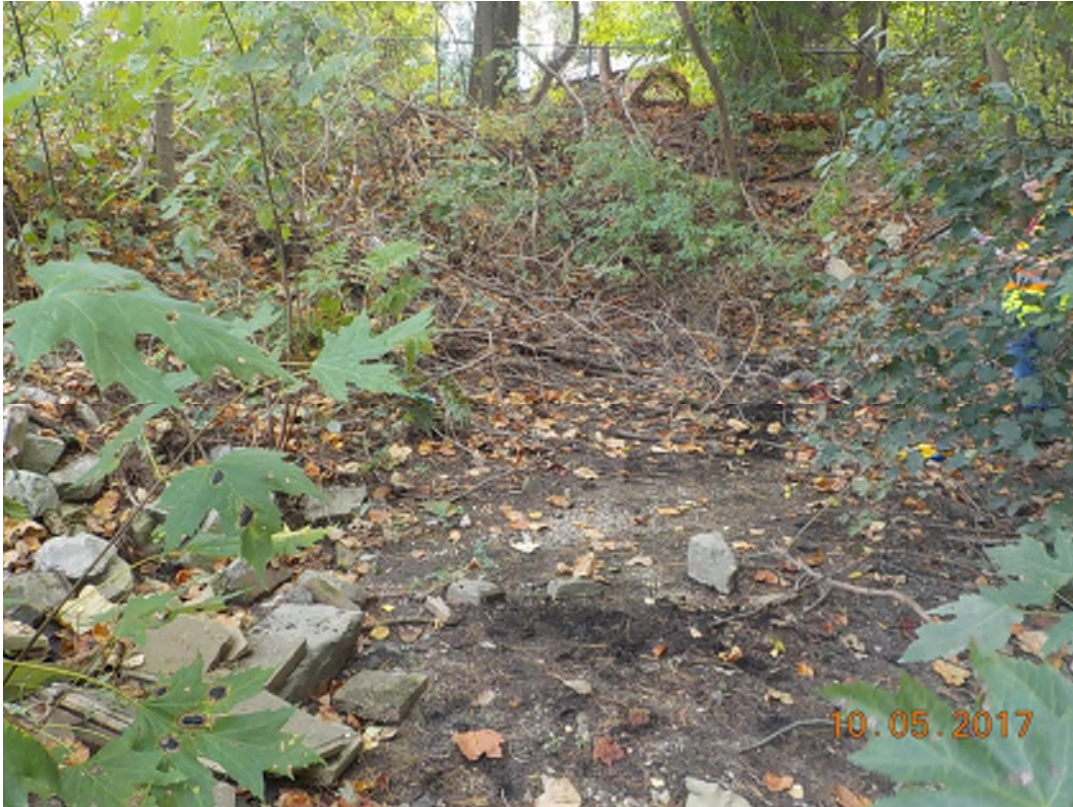
Figure 16: Existing BMP 7 is an infiltration basin located between 900A South Main Street and Homestead-Wakefield Elementary School. Flow enters facility via curb opening from parking lot. Facility is filled with approximately one foot of sediment deposition.

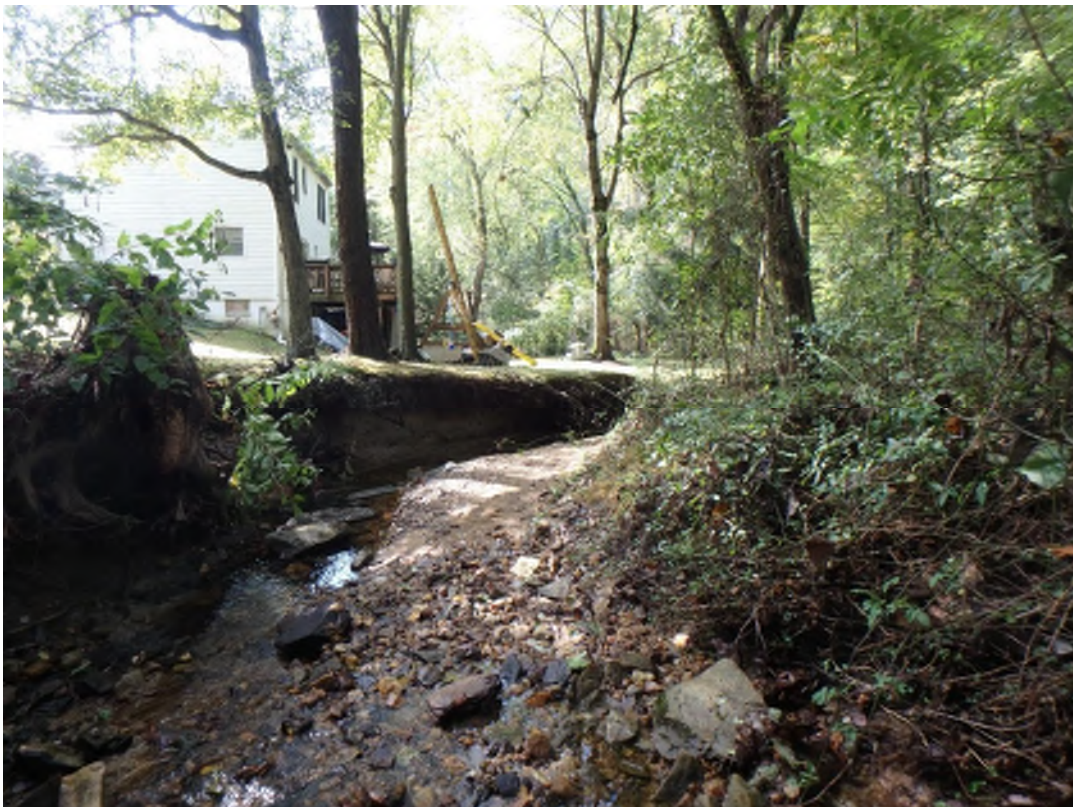
Figure 20: Tributary 1 inadequate buffer extending from outfall 6 to confluence with Brook Hill and Fairmont subwatersheds.

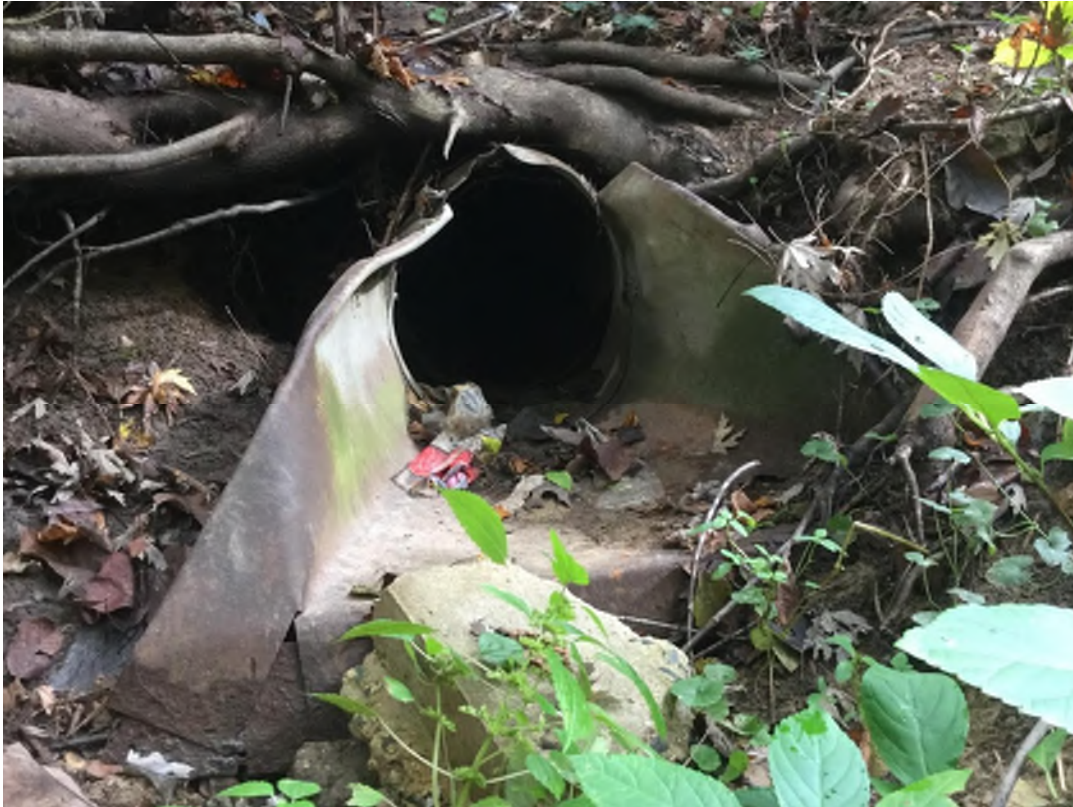
Figure 21: Outfall 7 is an 18-inch metal pipe conveying flow to left bank of tributary 1. Outfall is 7 feet from left bank of stream.

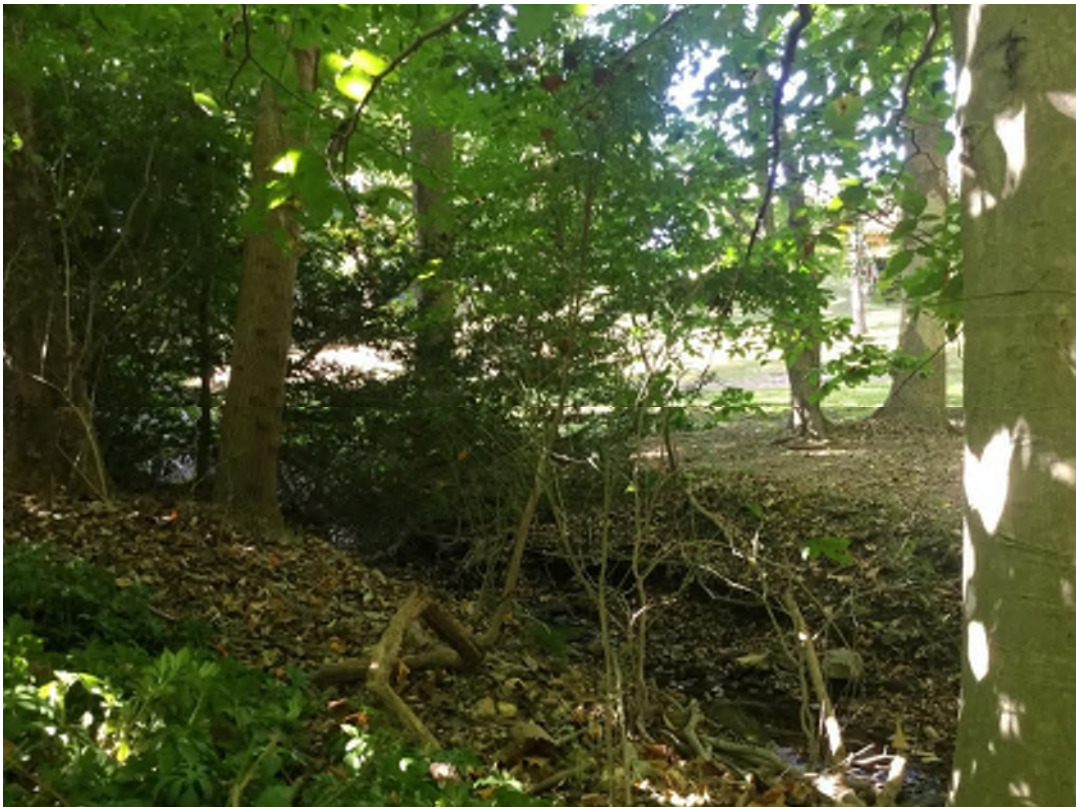
Figure 4: Lawn comes to edge of stream. Inadequate buffer in tributary 2.

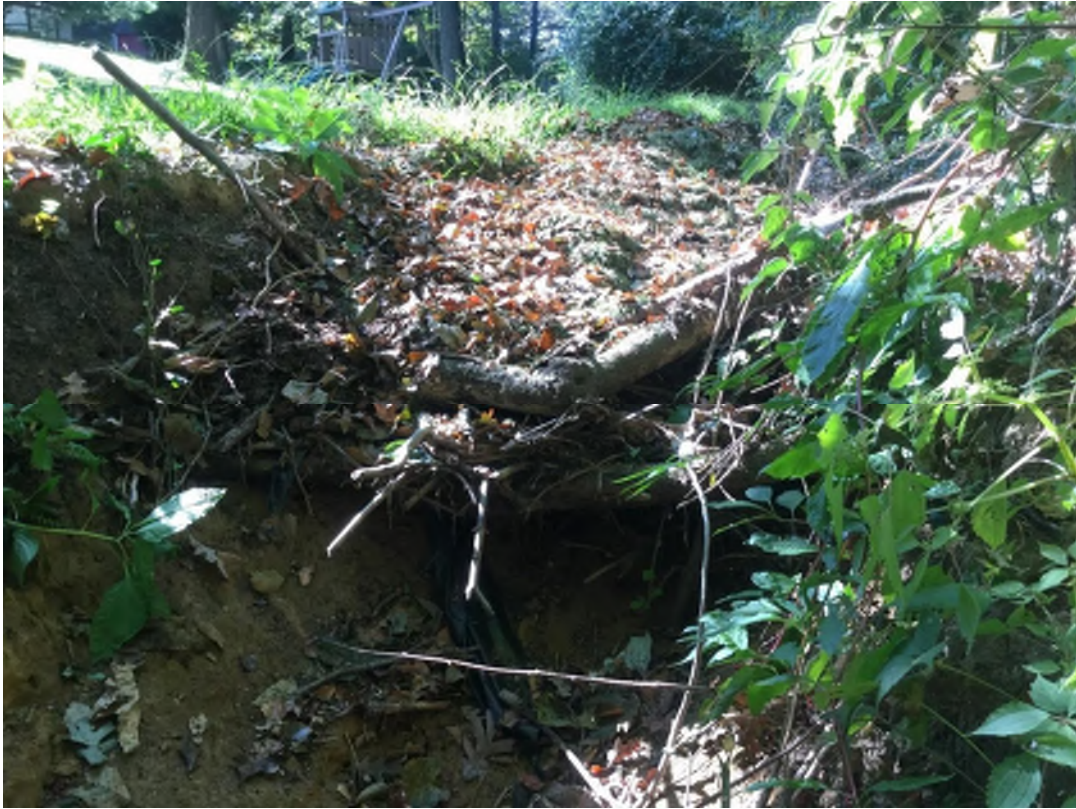
Figure 5: Channel drop of approximately 1.75 feet in tributary 2.
